Aga Khan Historic Cities Programme

URBAN CONSERVATION AND AREA DEVELOPMENT IN AFGHANISTAN

AGA KHAN TRUST FOR CULTURE

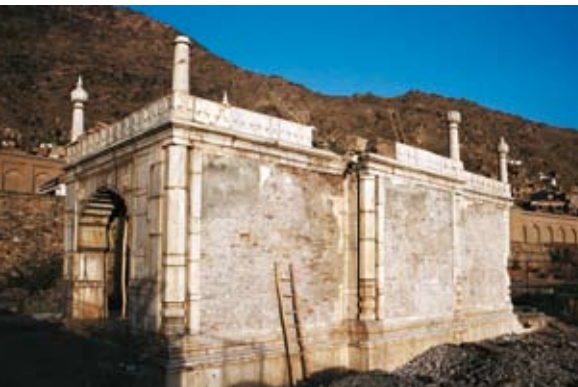
The west elevation of the Shahjahan Mosque prior to and during replacement (below) of the marble facing.

Following a detailed survey, conservation of the mosque was initiated in 2003 with the removal of the modern roofing and laying of traditional lime concrete, and replacement of cracked marble structural elements. Missing sections of the parapet were replaced with original marble elements rediscovered elsewhere in the garden, and the *mihrab* wall was re-faced, using some of the original marble pieces which had been laid as paving around the mosque. Staining on the marble elevations was cleaned, and some graffiti removed, but surface damage sustained during the fighting in the 1990s has been left visible.

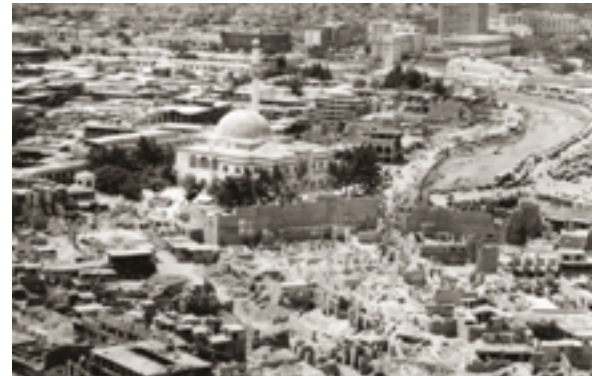
View of war damage in 1993 around Pul e Kheshti Mosque, with ruins of the Char Chatta commercial area in the foreground.

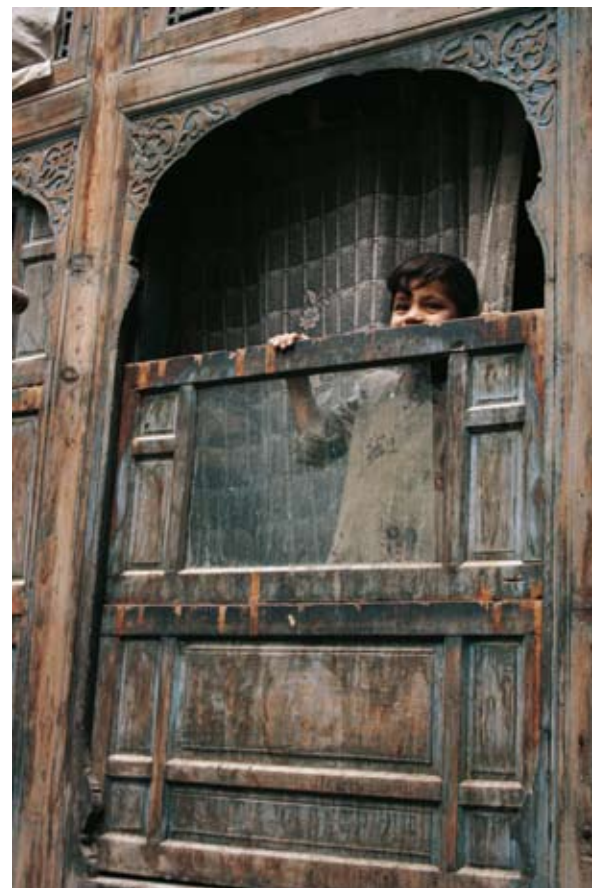
Families repairing and re-building their war-damaged homes in the old city.

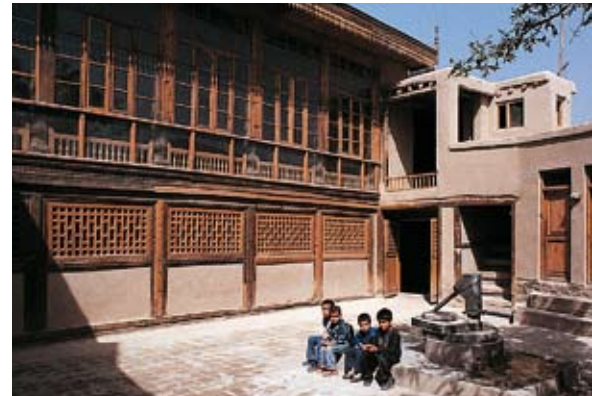
The courtyard elevation of the restored Uzbekha Mosque.

water supply was improved and facilities for sanitation were installed. The Uzbekha Mosque was back in full use in early 2005, since which date four other community mosques in the area, Khoja Faqir, Sehdukan, Chukorak and Mullah Ghulam, have been documented and repaired, with the active participation of members of the community. In each case, handpumps have been installed on the all-important communal well in the courtyard, and facilities for ablutions upgraded.

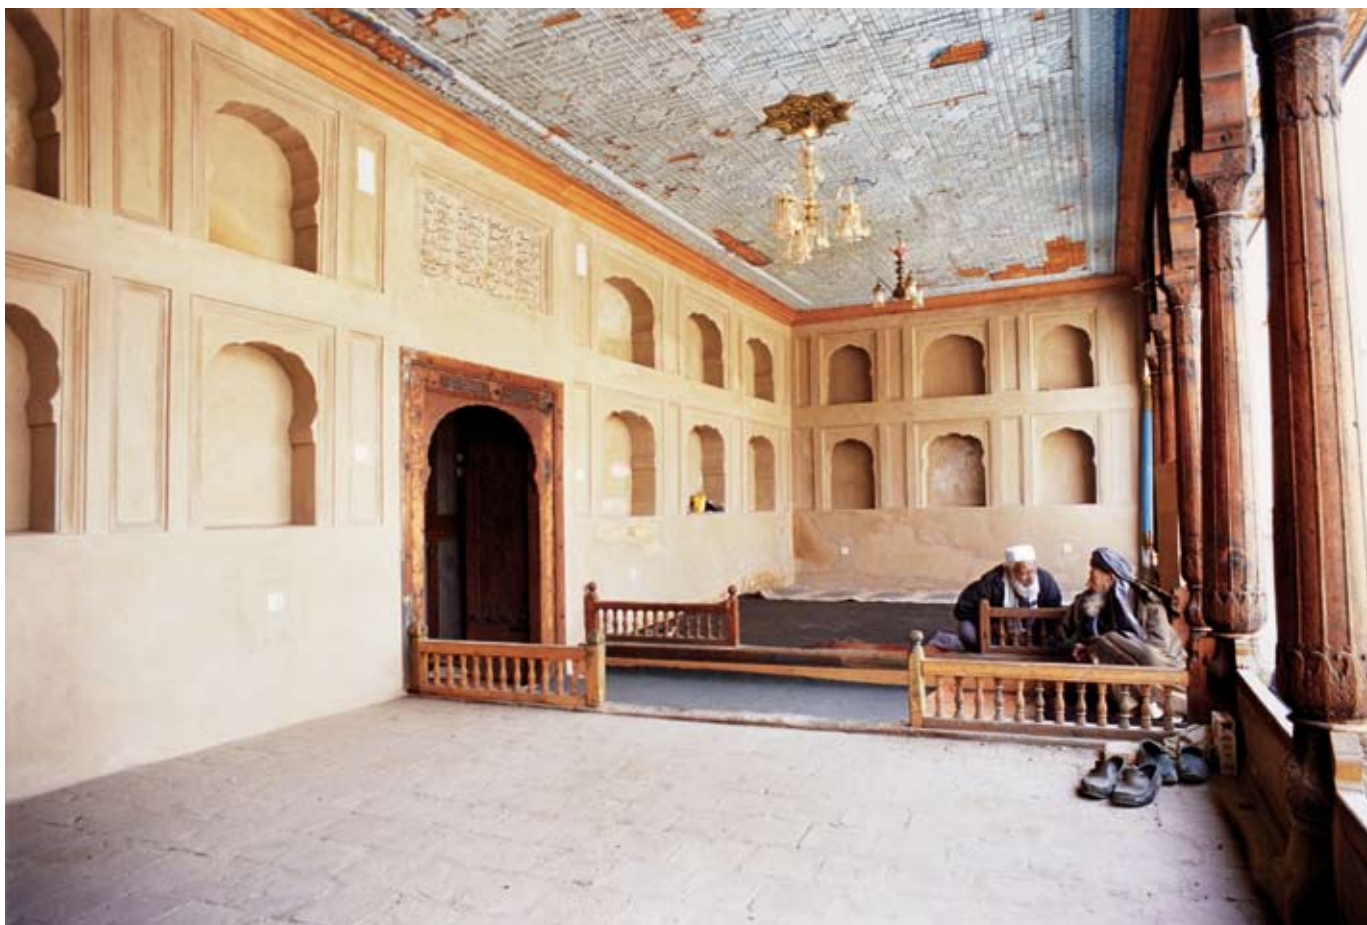
The restored entrance portico of the Asheqan wa Arefan shrine.

Building on the experience gained during the conservation of the mosques, and using information from detailed surveys, work was initiated on the Asheqan wa Arefan shrine in late 2005. A modern concrete structure had been erected over the grave of Khoja Abdus Salam, which stands in the midst of a larger graveyard, and is accessed by means of a mosque-like timber portico, leading to a semi-underground corridor lined with fine lattice screens. Repairs were carried out to the roofs of these structures, which were found to be close to collapse, and a stone retaining wall built along the length of the corridor, to protect the timber

screens, which were cleaned and repaired, along with the fine carved timber entrance door. During the course of repairs to the plaster, a series of decorated plaster niches were uncovered on the walls of the portico, and restored. The entire roof over the lower grave of Khoja Abdus Samad was re-built, and internal plaster and marble decoration restored. Extensive repairs were also carried out on the roof of the adjacent mosque, which dates from the early 20th century and retains fine decorated plasterwork on the *mihrab*. Work continues on the repair of the domed winter mosque beneath this, and on the landscaping of the shrine courtyard, which is an important focus both for pilgrims and residents of the neighbourhood.

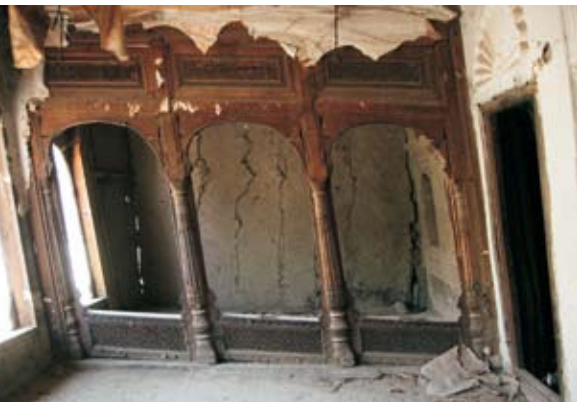
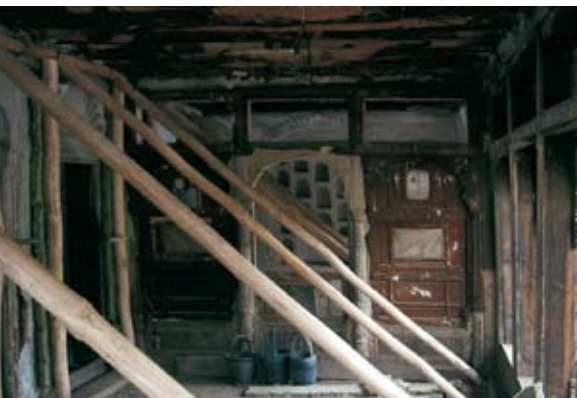
Deflection of the internal walls and timber screens (above) on the first floor of the Wasay house and props in place during stabilisation.

The availability of photographs of the Wasay house from the early 1990s enabled the AKTC team to identify elements that had been damaged or looted during the course of the subsequent conflict. The first task, however, was to remove layers of earth material from the roof, prior to temporary propping of the timber structure which, together with lattice screens, had undergone serious deflection due to the failure of a mud-brick gable wall. Once this wall was re-built, the timber frame was gradually jacked back in stages to something approaching its original position, to regain its stability. To limit damage to plaster decoration, sheets of soft waste foam were fixed over the walls during the course of this jacking. Once upright, excess plaster and whitewash was carefully removed by hand, exposing sections of fine moulded decoration. This enabled the reconstruction in the new west wall of a replica of the surviving decoration on the internal east elevation of this space. As with many homes of this era, a series of recessed niches, or *chinkhana* (used for the display of porcelain), can be found in the main

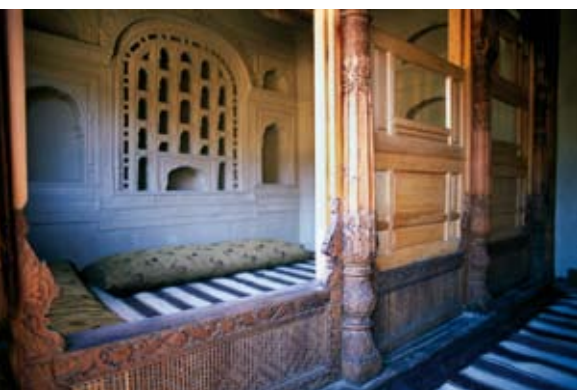
The interior of Wasay house with new and restored wood work.

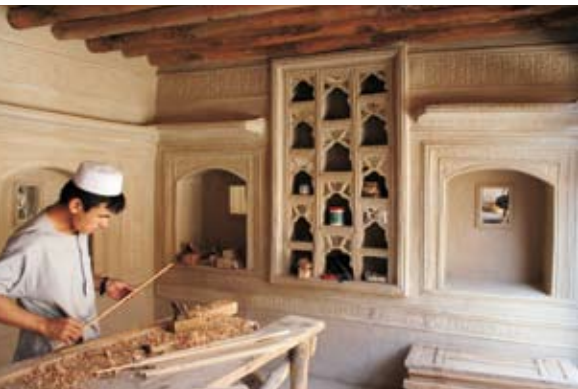
Carpenters at work repairing timber lattice-work screens.

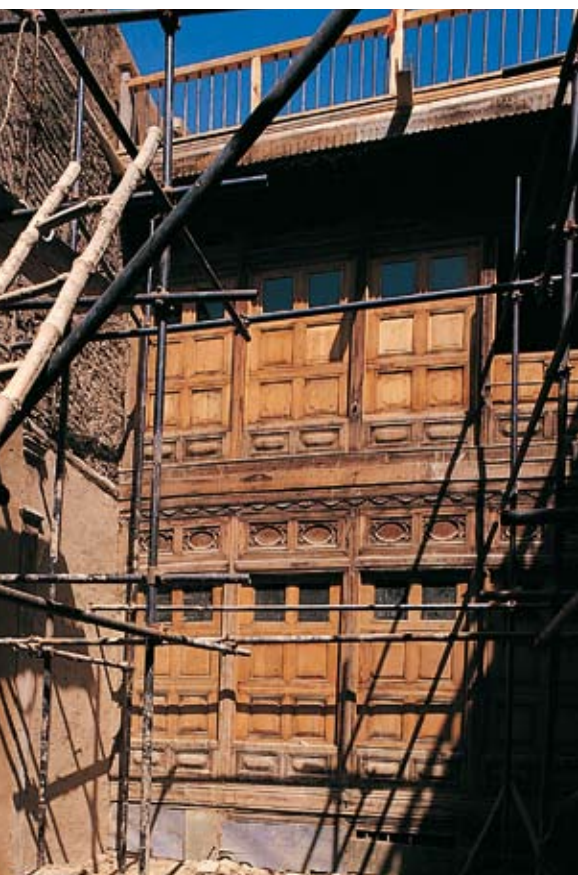
Courtyard of the Amin house during conservation works.

Based on initial surveys during 2003 of surviving historic homes in Asheqan wa Arefan, several were identified for possible conservation, based primarily on an assessment of their architectural value and vulnerability. The first intervention began in early 2004 on the house of Mohammed Amin, which retains a range of fine timber work dating from the turn of the century. Still inhabited by the son of Yasin Najjar, the carpenter who originally built it, the house is arranged on three levels, including the half-basement, around three sides of a courtyard. The first stage of work entailed jacking-up the timber-frame to correct the settlement that affected the stability of the structure. This was followed by repairs to load-bearing mud brickwork in the external walls, and replacement of mud-brick infill between the seismic-resistant *sinj* framing on upper levels. Moulded plaster and carved wooden decoration and ceilings were then carefully cleaned, and the sliding timber shutters, or *patai*, repaired.

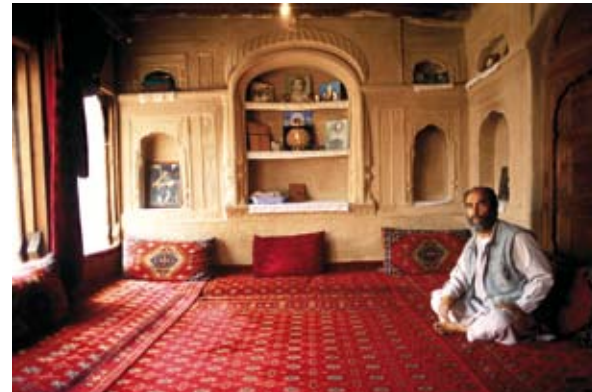
Interior of the restored Mohammed Amin house.

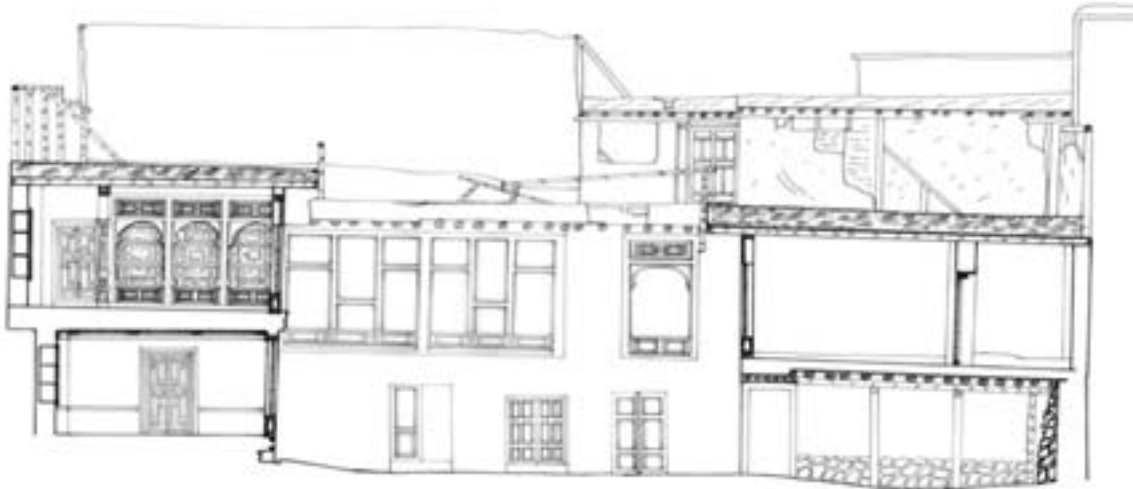
Brick infill is removed from the timber structural frame during restoration of the Shekiba house.

The introduction of improved services was also important in the conservation of the nearby Shekiba house, an example of a highly compact home that had family rooms on all four sides of a tiny courtyard. This was the first house in which the skills of AKTC's carpenters were tested in the reconstruction of an entire elevation of *patai* screens. Skilled joinery work was also important in producing replacement timber panels that had been looted from the Khaluddin house. Oriented to the north over the old city, the house has an unusual clerestory to gain light for the high-ceilinged internal reception space, which retains some fine plaster decoration.

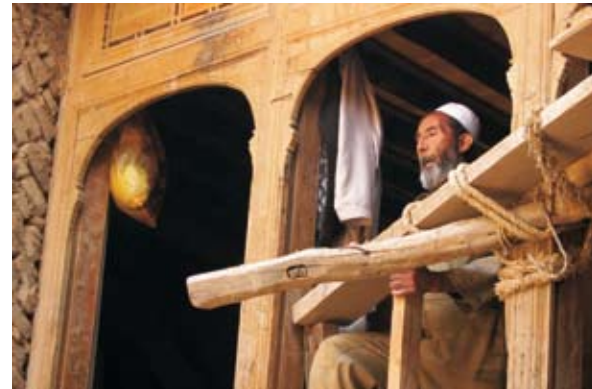
Carpenter at work in the Ruhullah house during conservation and, below, the interior of one of the ground-floor reception rooms after restoration.

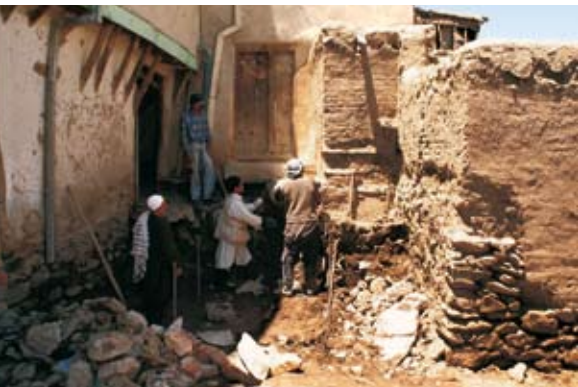
The removal of accumulated materials from alleyways in preparation for paving and laying of drain and water pumps has contributed to the improvement of living conditions for many families.

Having identified and mapped key environmental ‘pressure points’ in close consultation with residents, priorities were established for a range of labour-intensive initiatives that would have an immediate impact on living conditions. This has included removal of accumulated mud and waste from alleys and streets, often a metre or more deep, prior to laying of stone paving, which incorporates a system of surface channels leading from homes to repaired drains under the main streets. To date, nearly three kilometres of open drain have been laid using community labour in Asheqan wa Arefan, Chindawol and Kuche Gharabat neighbourhoods, while a similar length of underground drains has been repaired or built.

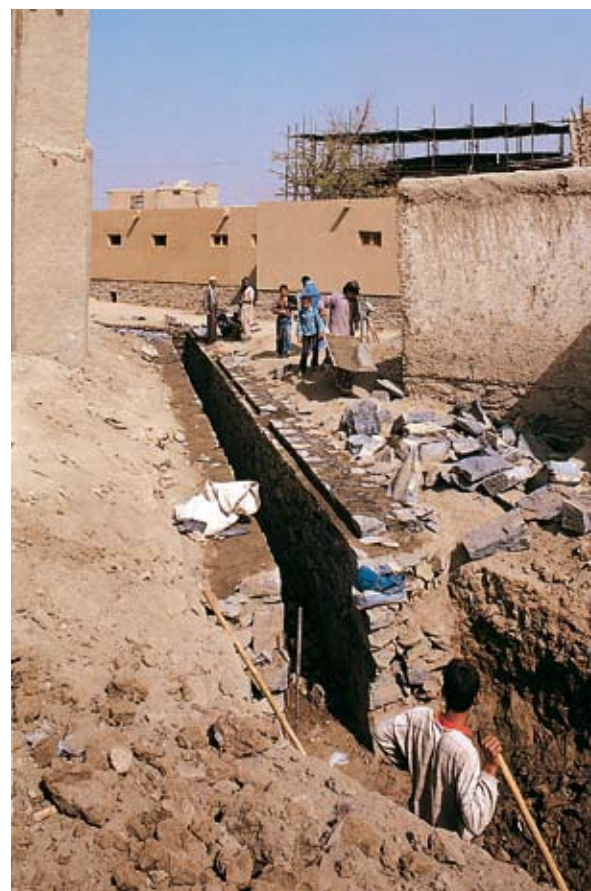
Drainage improvements are a priority for the inhabitants of Asheqan wa Arefan who are involved in all aspects of AKTC's work in the neighbourhood. Women are encouraged to participate in project discussion.

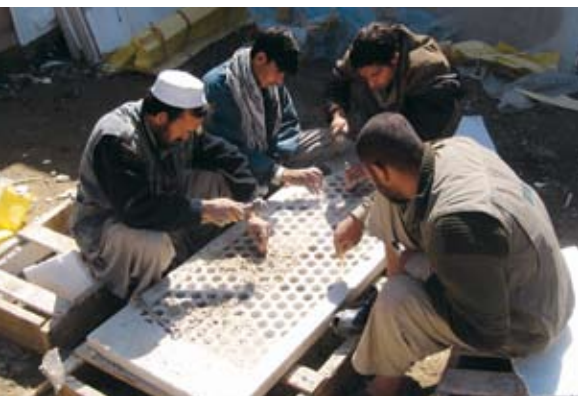
Craftsmen finishing the marble jali screens, and the completed marble inner enclosure. (See also picture, top page 24.)

platform. Measuring some 4.5 metres square, the elevations of the reconstructed enclosure comprise a central arched opening flanked by pairs of marble lattice or *jali* screens. Now re-planted with *arghawan* trees, the area between the marble screen and the outer enclosure, where the grave of Babur's son, Hindal, survives, provides a tranquil space in which visitors can pay their respects.

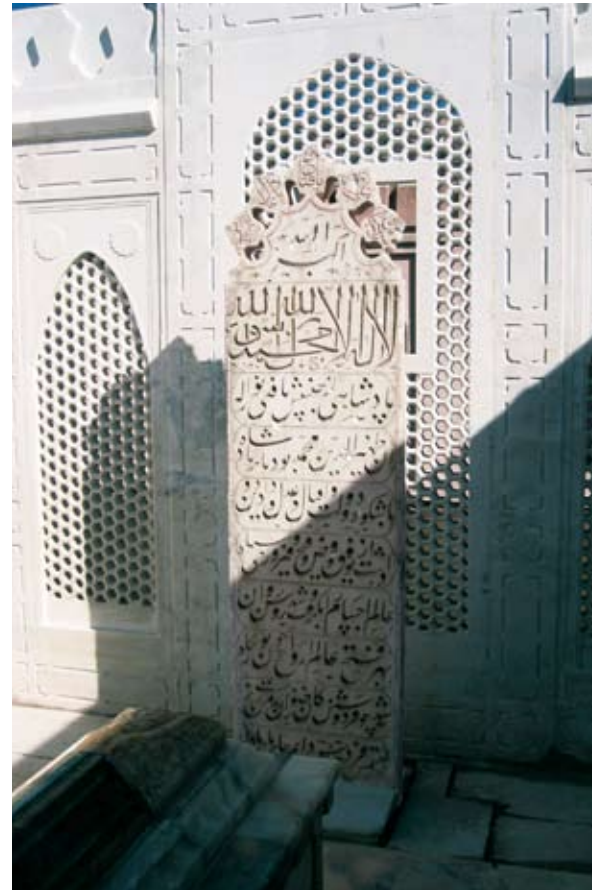
Above: Babur's gravestone within the reconstructed enclosure.

Below: The completed reconstruction from the north, with outer (brick) and inner (marble) enclosure.

Left page: The outer brick enclosure under reconstruction in 2005 on the original stone platform, which was rediscovered during archaeological excavations.

Based on archaeological excavations and a review of earlier documentation, the work undertaken since 2002 aimed to re-establish the original character of the grave area in a manner that conforms to international conservation practice. The level of the southern end of the terrace was lowered to restore the original elevation of the grave platform, around which the outer arcaded masonry enclosure has been reconstructed, on foundations of a 17-metre-square stone platform revealed by archaeological excavations, indicating that this had been built around and above older graves.

The 31 marble fragments found in the grave area yielded important evidence as to the style and workmanship of the original enclosure around Babur's grave. While it has long been held that the enclosure dates from the time of Shahjahan, the craftsmanship and motifs on the recently rediscovered fragments suggest that it might in fact date from soon after Babur's burial. Together with documentary material, the fragments have enabled the reconstruction of the enclosure, carved from Delhi marble, which has been erected *in situ* on the original grave

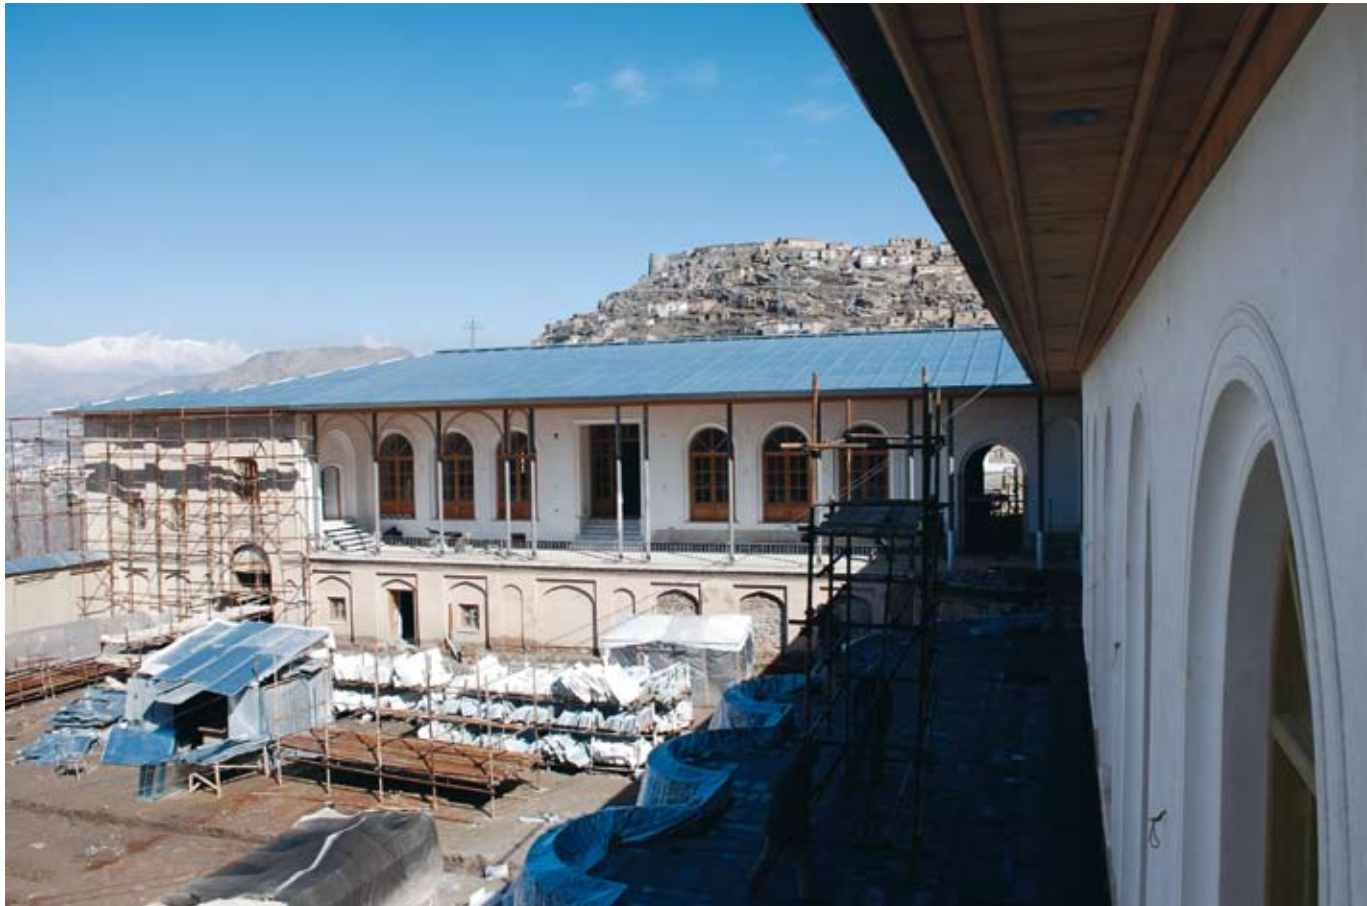
Above: Two views showing the courtyard of the Queen's Palace, the upper prior to reconstruction, and the lower in 2006, during the course of the works, with a theatre performance going on.

the clearing of unexploded ordnance and mines, the collapsed sections of the *haremserai* roof were removed and the entire complex surveyed. One space to have escaped destruction was a brick-domed *hammam*, whose decorated plaster was restored in 2004. Following consolidation of the ruined structure in 2005, work began on the redevelopment design, based on the footprint of the original structure and referring to historic photographs.

Reconstruction work began in early 2006. While respecting the architecture of the original building, it has been possible to incorporate a range of alternative uses into the reconstructed complex and integrate new services. Moreover, this has provided an opportunity to develop the skills of a sizeable team of Afghan craftsmen in a range of building techniques, including brick vaulting, joinery, decorated plasterwork, marble flooring and stone carving. It is envisaged that the restored *haremserai* and its large courtyard will be a focus for public events, the revenue from which will be used to meet the costs of upkeep of the garden.

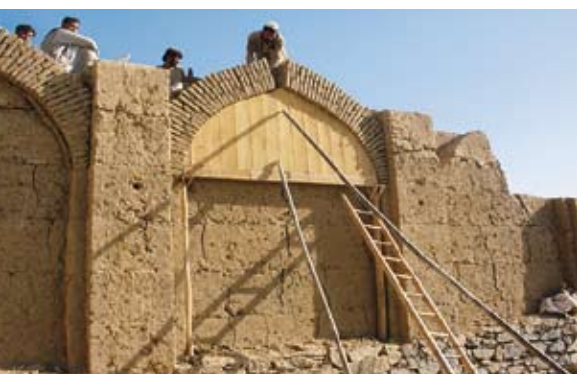
Reconstructed northern perimeter wall, with informal settlement on the slopes above.

Reconstructing mud-brick arches between pakhsa piers in the perimeter wall.

Although it is not clear how Babur defined the extent of his garden, the perimeter walls that now surround Baghe Babur follow the tradition of enclosure of formal Persian gardens. Jahangir's instruction in 1638 that walls be built around several gardens in Kabul probably included the site now known as Baghe Babur. The scale and alignment of these walls has doubtless changed, but surviving sections of *pakhsa*, compacted earth walling laid by hand, were surveyed in 2002. With many sections found to be close to collapse, nearly 1.5 kilometres of walling (parts of which are eight metres high and over two metres thick) were re-built or repaired in the traditional manner. An important secondary objective of this work was the generation of employment among displaced families who were then returning to their homes in the neighbourhood.

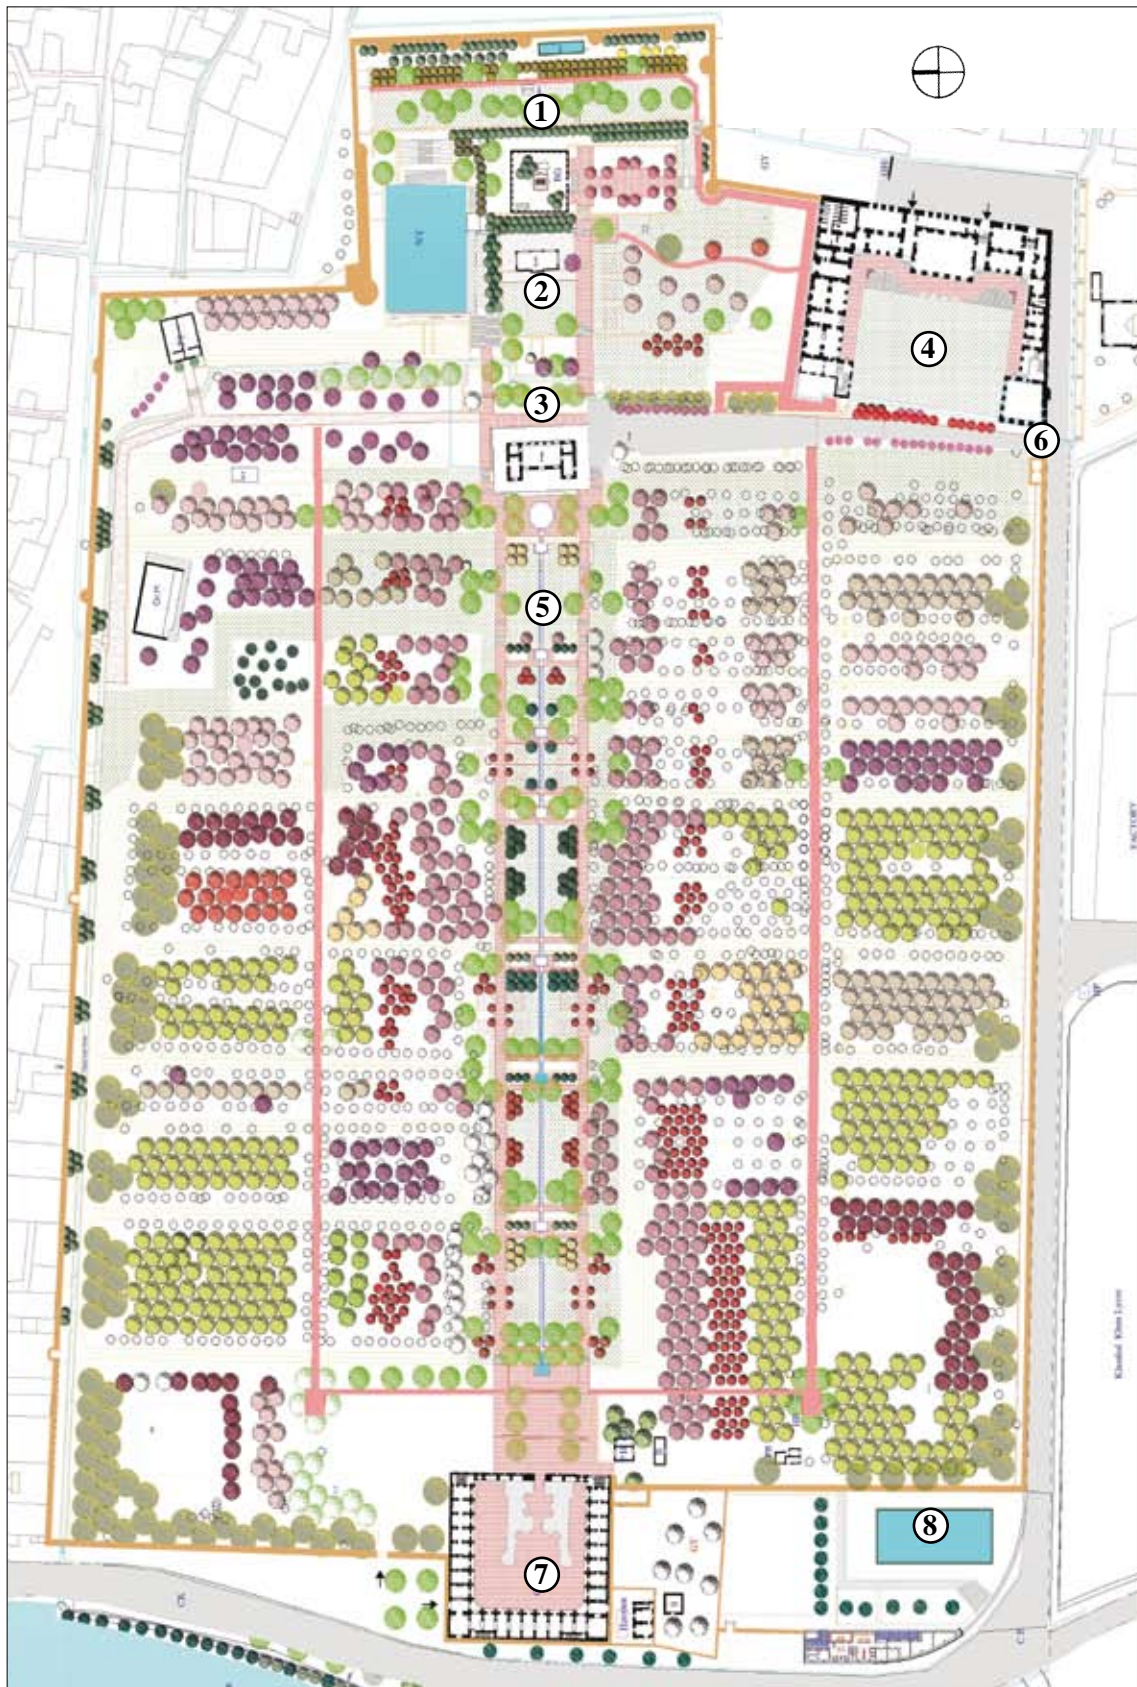
Plan of the restored Baghe Babur with its central axis, its planted terraces and its buildings and annexes.

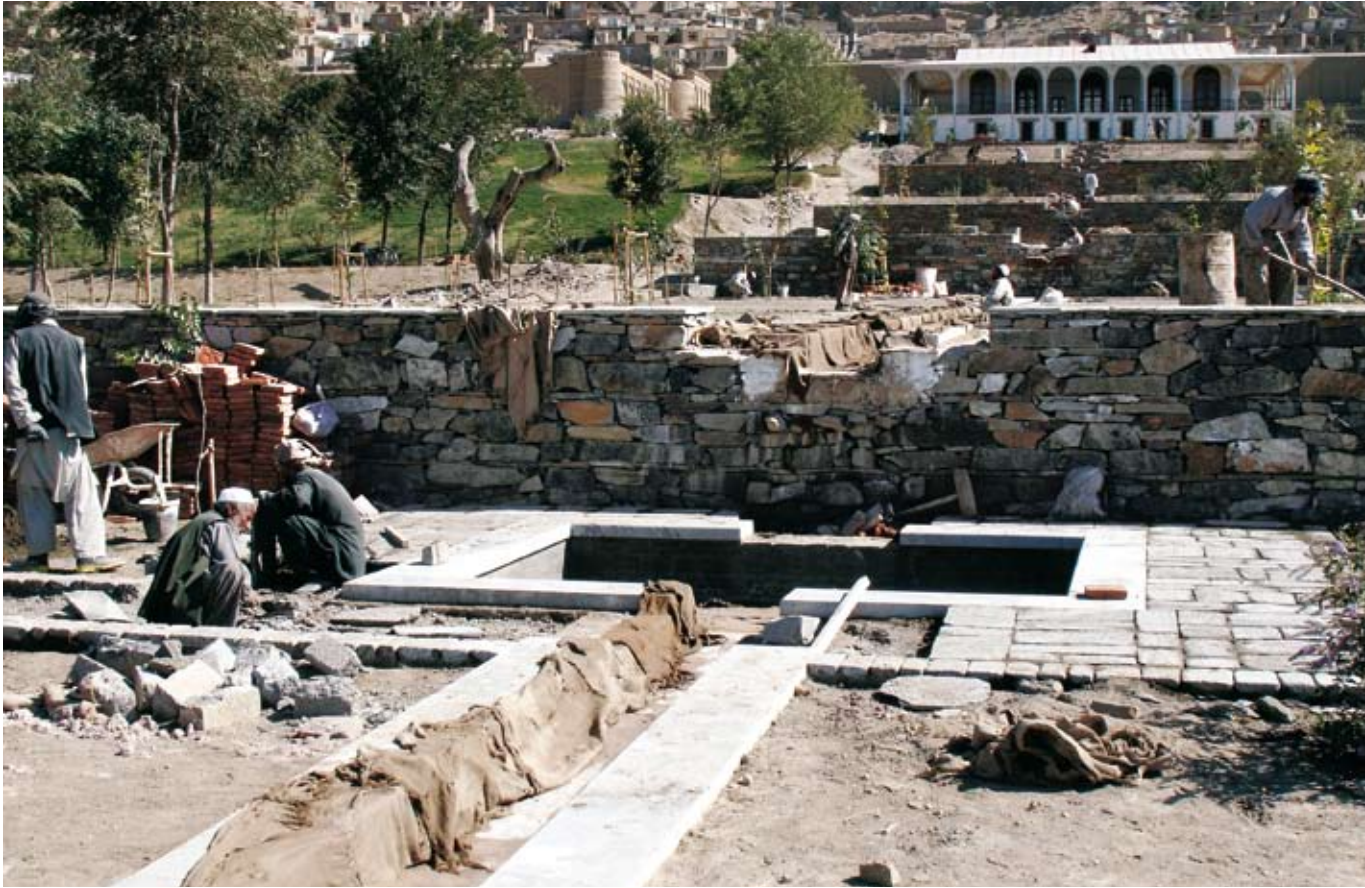
Above left: The central axis viewed from the east during rehabilitation, with the octagonal brick Mughal-era pool being excavated in the foreground, and Nader Shah's fountains, prior to their being dismantled.

The reconstructed octagonal pool and water channel along the central axis, with stone paving and initial re-planting under way in 2005.

The dismantling of three 20th-century fountains enabled excavation to take place along the length of the central axis, where remains of eight rectangular tanks linked by channels, and sections of terracotta drainage pipe, as well as remains of stone retaining walls at the edges of terraces were found. In places, Mughal elements were found beneath more than 2.5 metres of deposits; they had been partly destroyed during the digging of a deep trench for pipes to supply the modern fountains. Fragments of three carved-marble waterfall elements of matching dimensions, which had been re-used as gravestones, were also discovered.

Together, these finds have enabled the team to reconstruct the central axis and its main water channel, allowing water to flow again, as it did in Babur's time. This has been achieved without significantly disturbing the surviving archaeological remains, which were backfilled after thorough documentation.

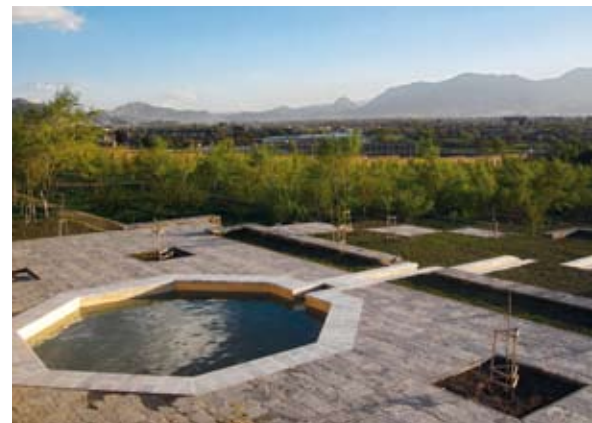
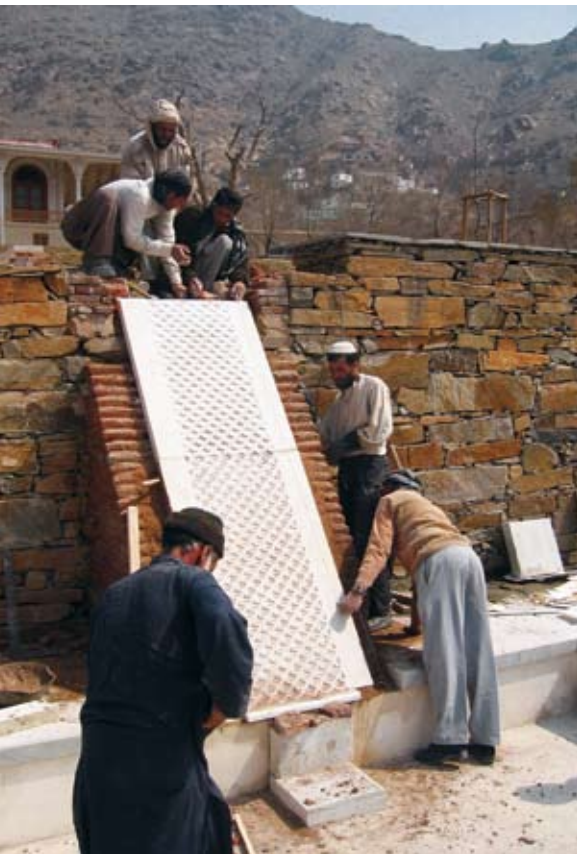
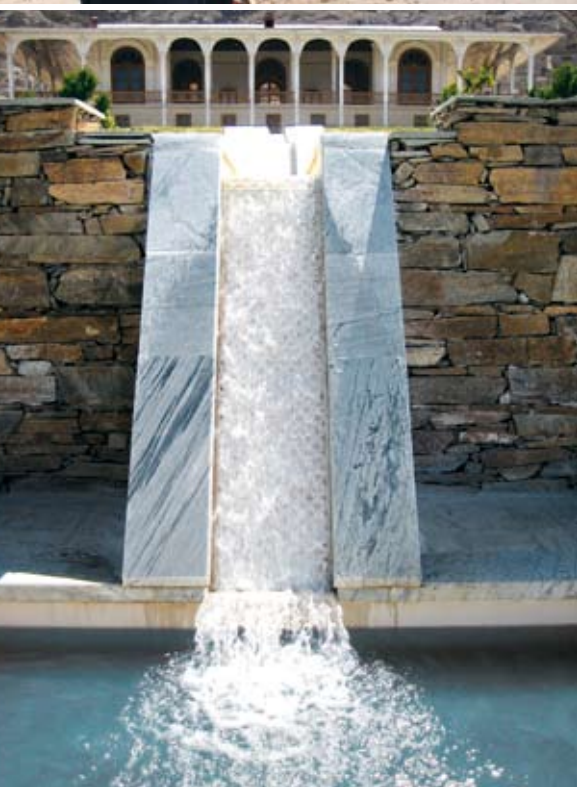
Workmen laying a stone pavement around one of the marble-edged tanks on the central axis and, below, the reconstructed octagonal pool on the ninth terrace.

At the head of the present central axis, a large octagonal tank (replicating the original that has been preserved underground) is surrounded by a copse of plane trees between which is an area of stone paving. From this level, there are views down the central avenue, and across the plain

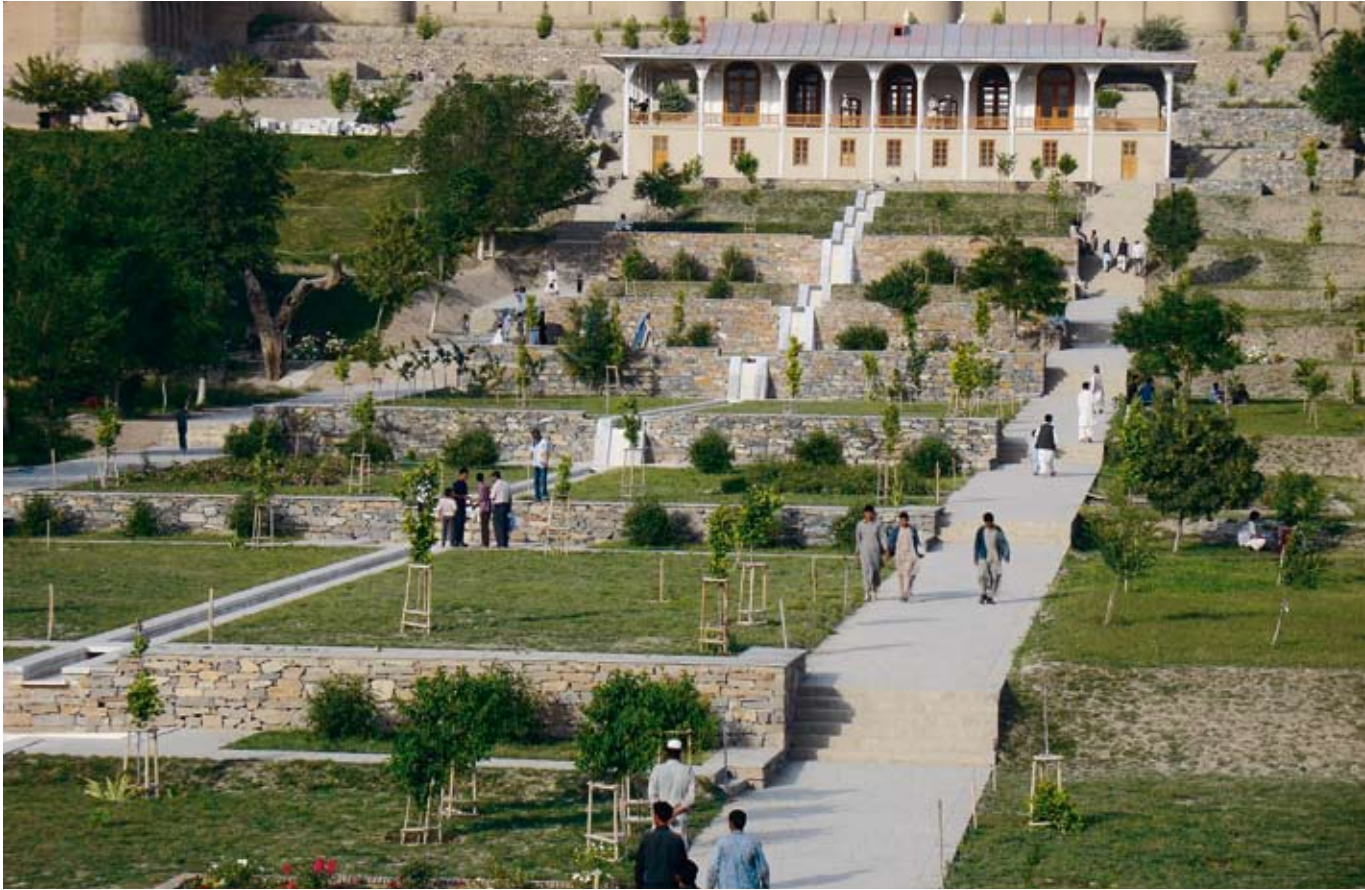
Installation of one of the marble waterfalls, carved to dimensions of fragments found on the site, and water flowing down from the upper terraces.

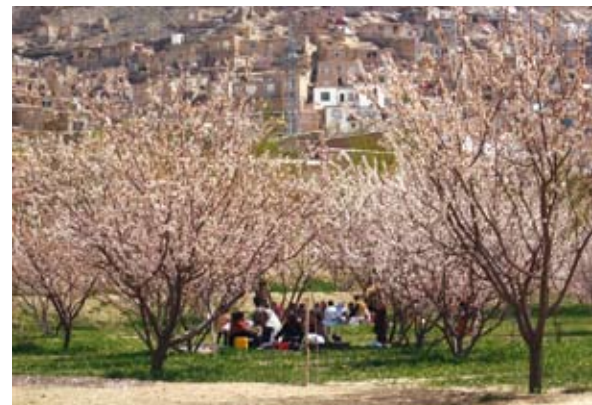
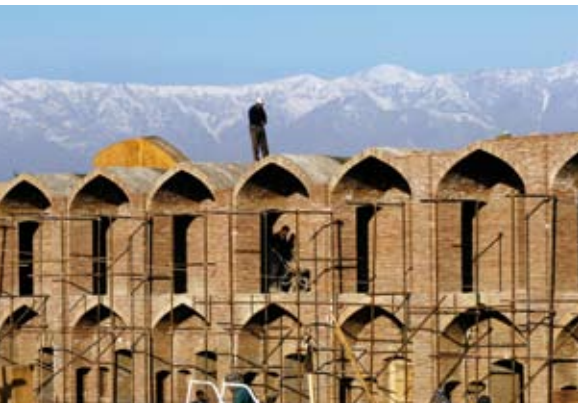
The new caravanserai complex uses traditional brick-masonry techniques. Below, the building near completion.

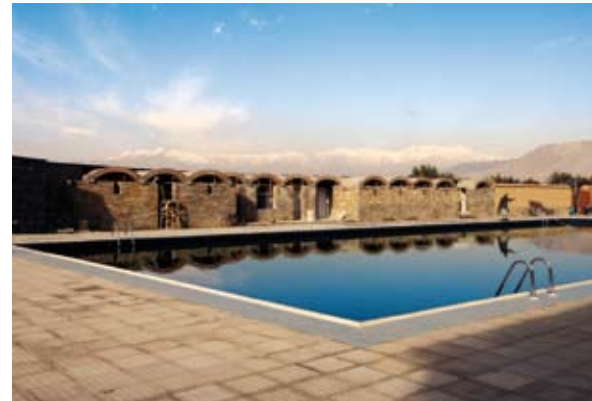
The new public swimming-pool adjacent to the caravanserai, which replaced the old swimming-pool that had encroached upon the garden. Below, a stone construction detail of the facilities.

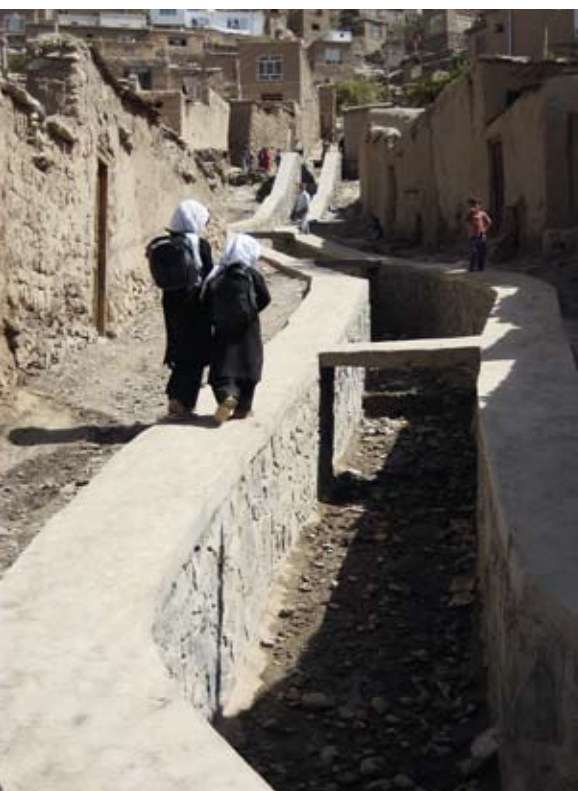
Newly built storm-water drain with pathways in the informal settlement on the slope above Baghe Babur.

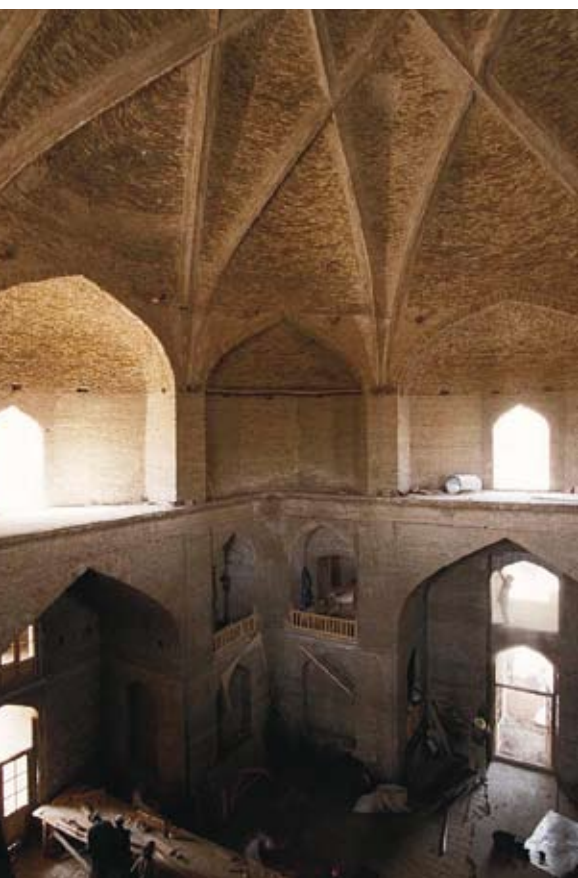
Interior of the mausoleum during restoration, showing the ribbed inner dome, built in brick.

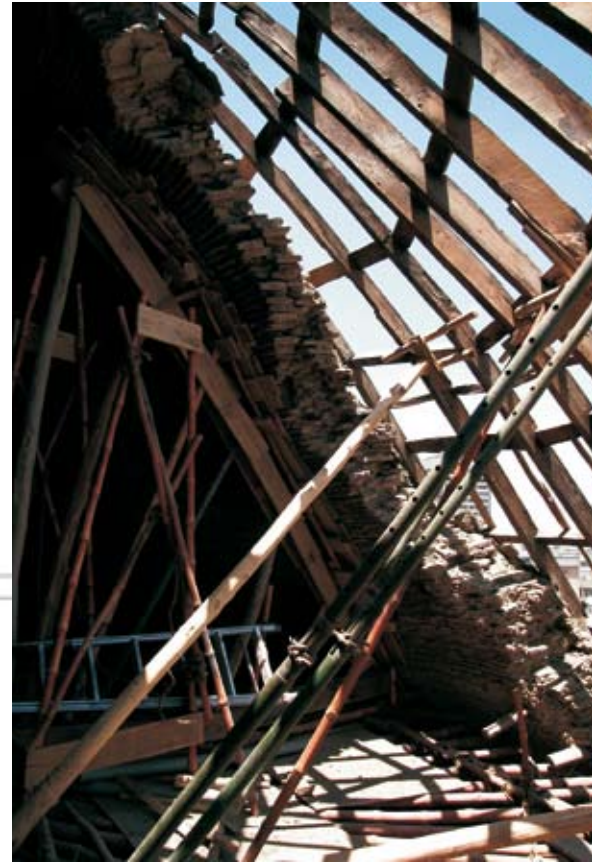
Prior to removal of unstable brick masonry, the damaged upper dome was propped.

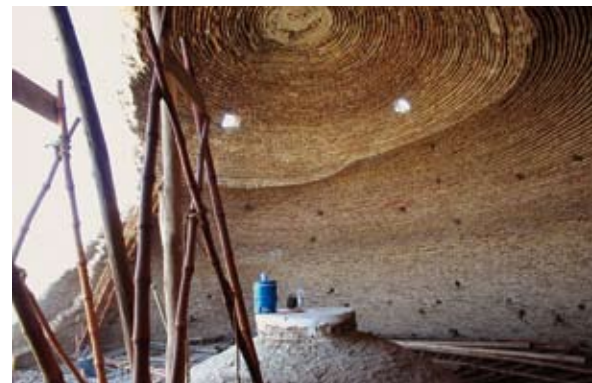
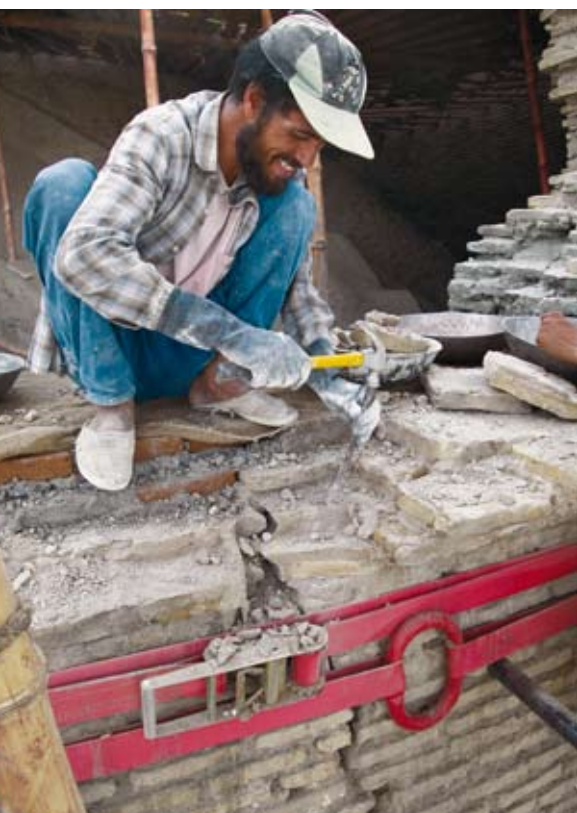
The drum of the upper dome was temporarily strapped during repairs to the masonry, for which specially fired bricks (below) were set in lime mortar.

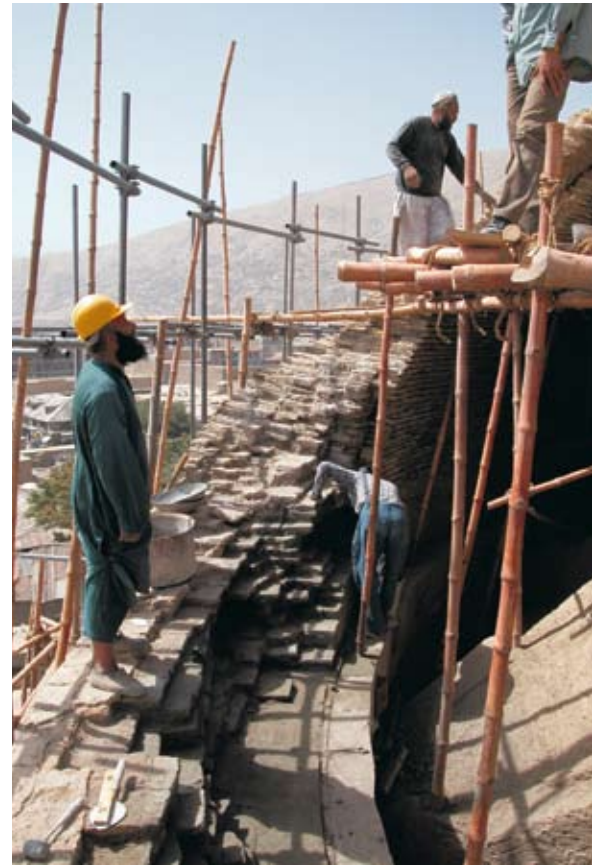
New brickwork being laid to match the coursing of the original dome.

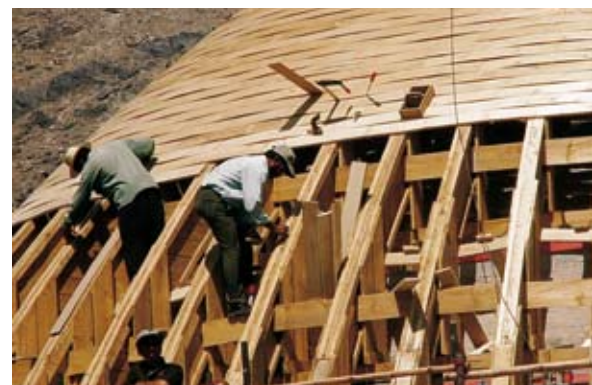
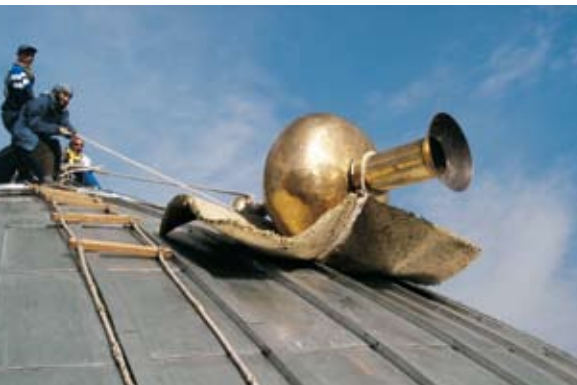
The repaired finial being raised to the apex of the dome and, below, the restored mausoleum with its new terrace at ground level.

A batten seam system of galvanised iron sheeting, which was familiar to local craftsmen, formed the final weatherproof covering of the dome. The lower edge of the shell roof was extended below the base of the rafters by means of timber boards that were bent, glued and screwed to the required radius, and fixed back to the drum masonry. This enabled protection of the drum masonry, while providing for ventilation around the entire lower edge of the roof.

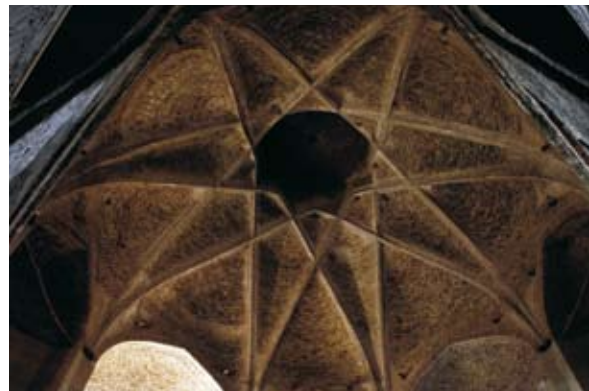
The ribbed brickwork on the inner side of the lower dome.

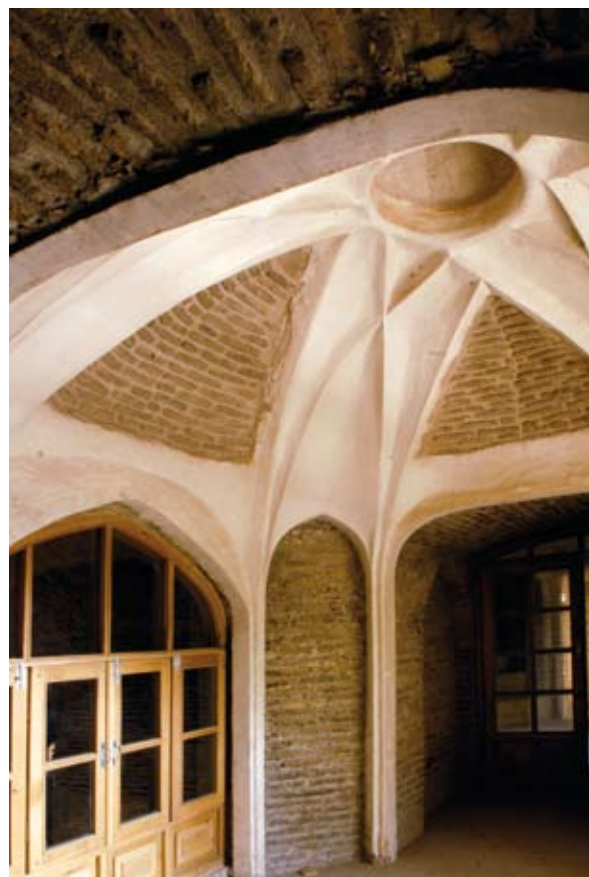
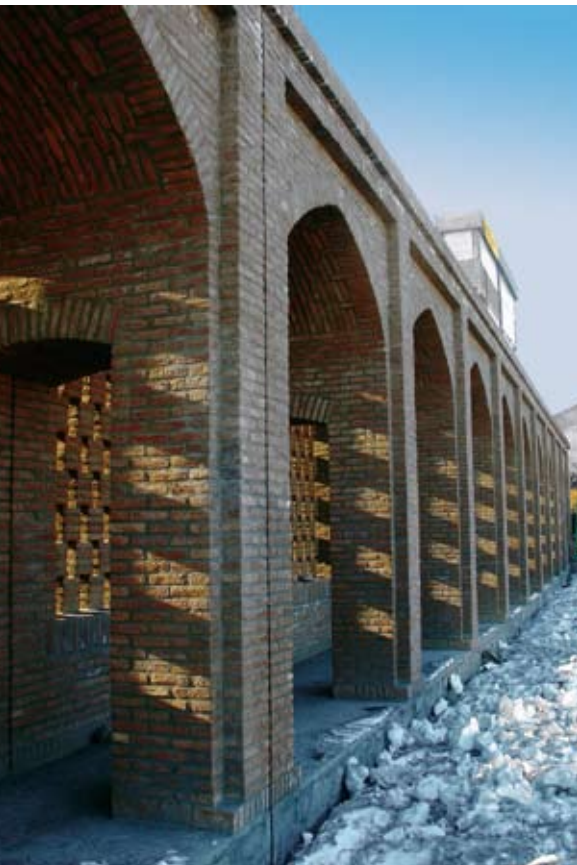
Recessed bays in the new brick perimeter wall around the reclaimed park.
