Aga Khan Historic Cities Programme

URBAN CONSERVATION AND AREA DEVELOPMENT IN AFGHANISTAN

AGA KHAN TRUST FOR CULTURE

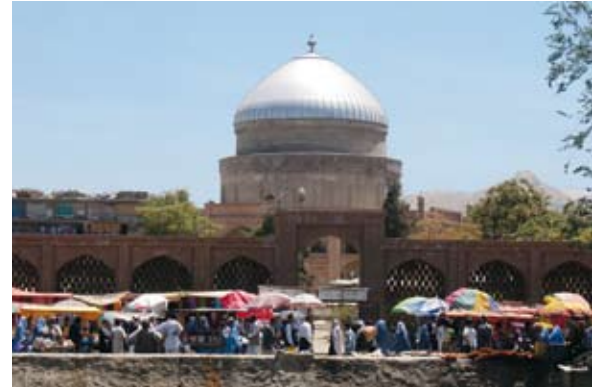
The arcaded wall on the north-west side, screening the park from the busy riverside street.

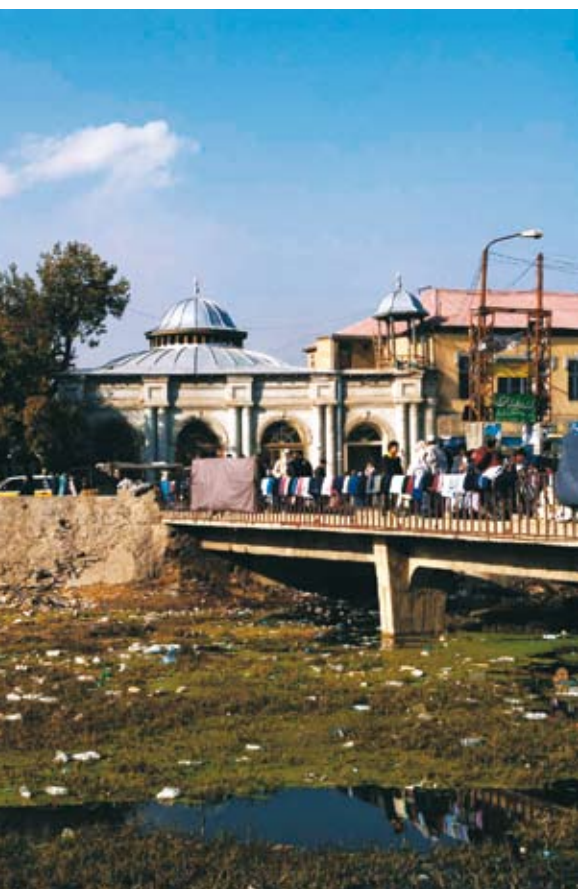
The Andarabi Mosque with its roof restored, in 2004.

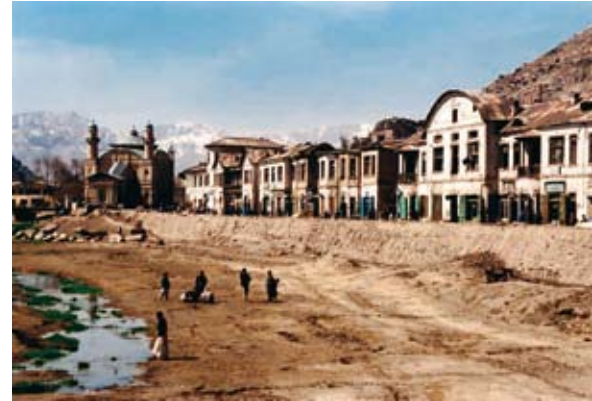
Early 20th-century facades along the Kabul River, adjoining the Timur Shah Mausoleum, have been renovated.

This double-storey range of riverfront buildings, with workshops over shops on the street level, is an important vestige of the introduction of western concepts of urbanism to Kabul. In recognition of this, the entire frontage was surveyed, damage assessed and the ownership of the various shops and workshops registered during 2004. Support was provided in 2005 for the repair of one of the central bays, both as demonstration of the potential of the building and as a deterrent to municipal planners, whose proposals for widening of the street envisaged wholesale demolition of the historic frontage.

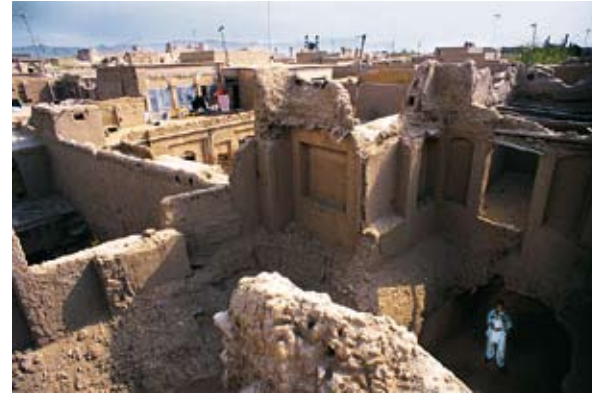
The traditional fabric in the western parts of Herat old city is in a poor state of repair.

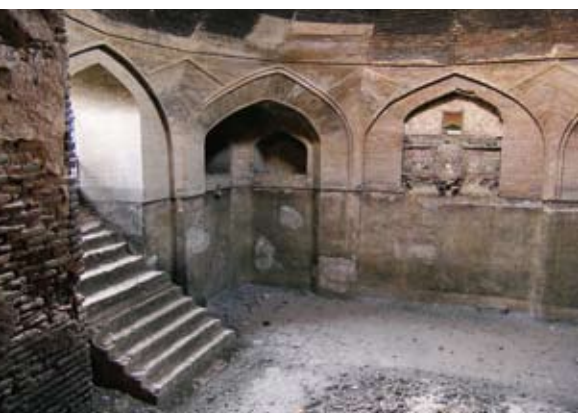
Interior of Châhâr Suq Cistern prior to restoration.

In parallel with support for upgrading of basic infrastructure, AKTC has embarked on the conservation of historic public buildings in two clusters, of which the Châhâr Suq and Malik Cisterns form the nuclei. In the case of Châhâr Suq, the focus was initially on repairs to the covered cistern built in 1634 and which remained a vital source of water for the inhabitants of the old city until the 1970s. With a clear span of 20 metres, the brick dome is the largest in the country. Built on a massive octagonal supporting structure, legend has it that the masons who raised the dome used straw-filled bags to support the faceted brick masonry during its erection. Having undergone a range of attempts at repair over the years, the structure in 2005 revealed significant settlement of parts of the superstructure, caused in part by excavation of brick masonry by shopkeepers in the adjoining bazaars. The first stage of conservation of the cistern entailed removal of more than a metre of accumulated earth from the roof, to enable examination of the state of the brick structure. Following replacement of damaged sections of brickwork around the dome, the roof surface has been finished with brick paviors. Subsequent interior work included repairs to brick relieving arches under the dome and the re-opening of vaulted openings to the east and south of the main space. The tank itself continues to be used as a subterranean workshop for AKTC's conservation in the old city, and will eventually be used for cultural or educational events.

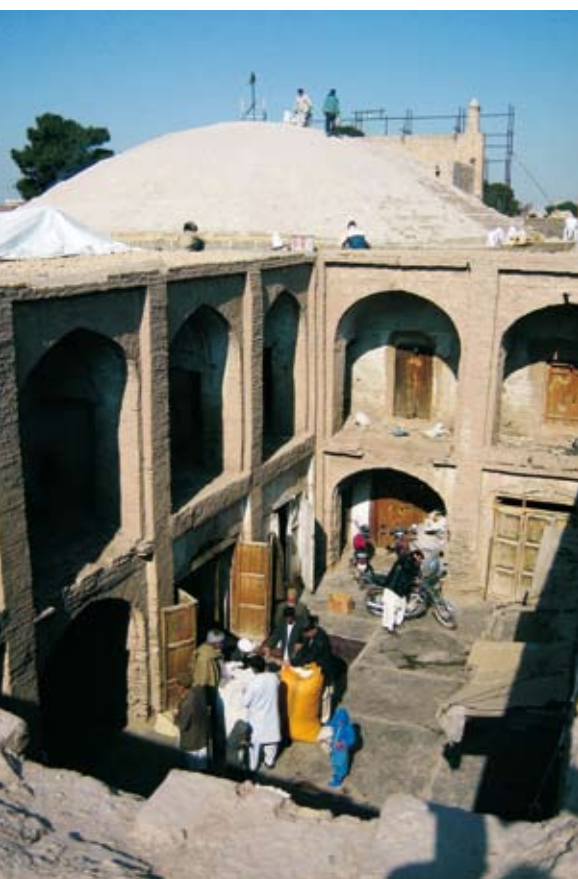
The Timche Qaysari Serai with the repaired dome of the cistern in the background.

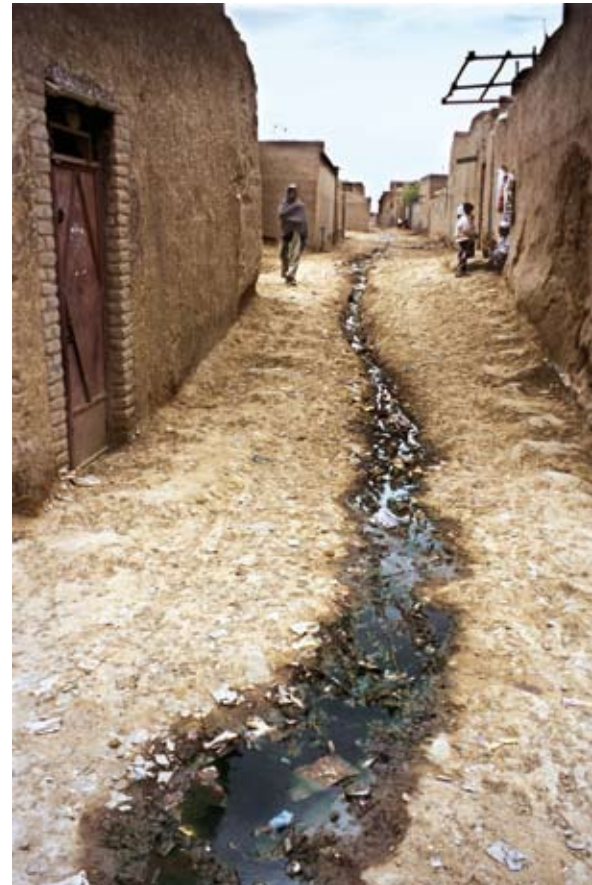
Open sewer between houses in the Bar Durrani quarter.

The findings of these surveys suggest that the upgrading of infrastructure will be critical to the recovery of the old city. In order to address some of the most immediate needs, support has been provided since 2005 by AKTC to community groups to organise the evacuation of liquid waste from fifty open sumps in residential areas. Along with repairs to drainage channels and collection of accumulated waste in the Bar Durrani quarter for disposal outside of the city, this initiative has directly benefited almost half of the population of the historic quarters. Given the density of settlement, many pedestrian alleyways have had

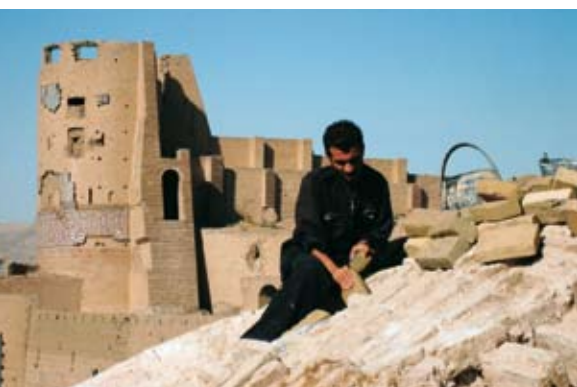
The Malik Cistern and Mosque complex under restoration and, below, preparing bricks for use on repair to the roof of the cistern.

summer/winter mosques. Repairs were then undertaken on the brick-masonry vaults and squinches that support a small brick dome spanning over the centre of a rectangular pool. The entire roof was then laid with a finish of brick paviors and, in order to protect the building from traffic along the adjoining street, the original plinth has been reconstructed. Work was subsequently initiated on the adjacent summer mosque, dating from Safavid times, featuring an open brick-arched *iwan* over a raised floor, from which modern concrete was removed and the vaulted sub-structure repaired. The high brick vaults over the prayer space were repaired and the original carved marble inscription fixed back in place. Removal of the modern plaster from the elevation and interior of the semi-underground winter mosque revealed sections of glazed tiling on the elevation of the modest *iwan*. This has been repaired, along with a raised prayer platform in front of the mosque and a row of vaulted study-rooms along the northern side of the courtyard. It is envisaged that the restored cistern will be re-used as an educational centre for the inhabitants of the surrounding neighbourhood.

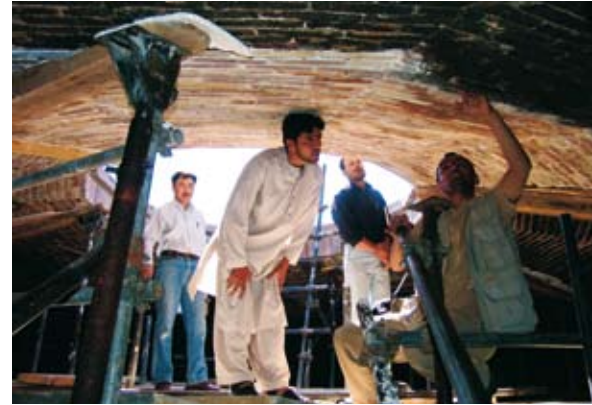
Inspecting repairs to the main dome over the Châhâr Suq Cistern and restoration work on the main entrance iwan of the complex.

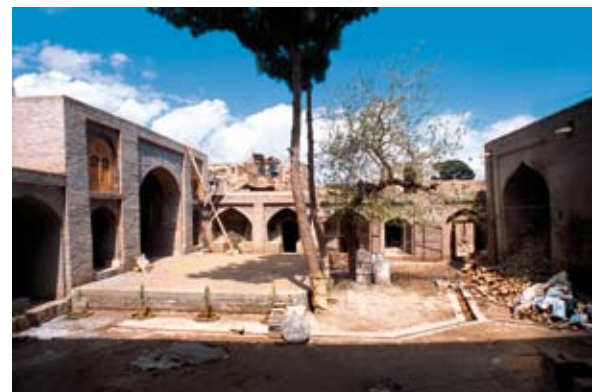
The Malik Winter Mosque and courtyard during rehabilitation works in 2007.

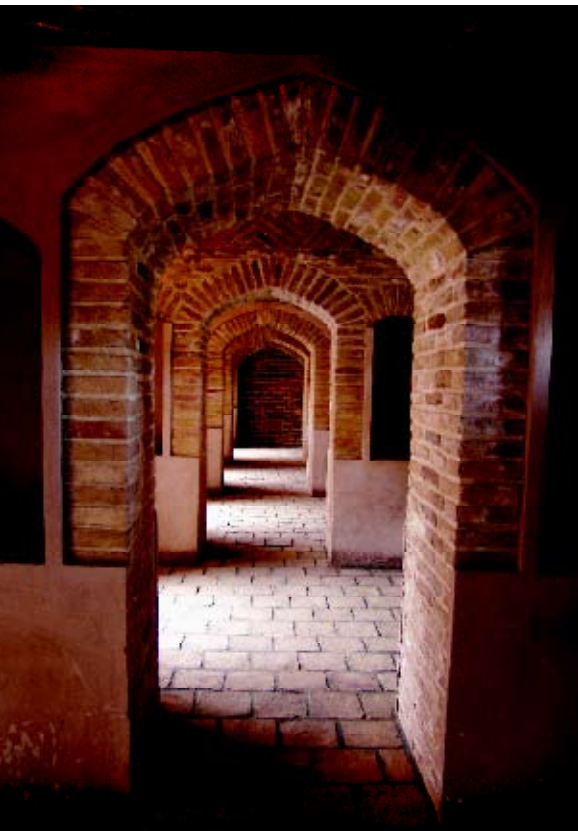
Interior of the Timche Qaysari after restoration was completed.

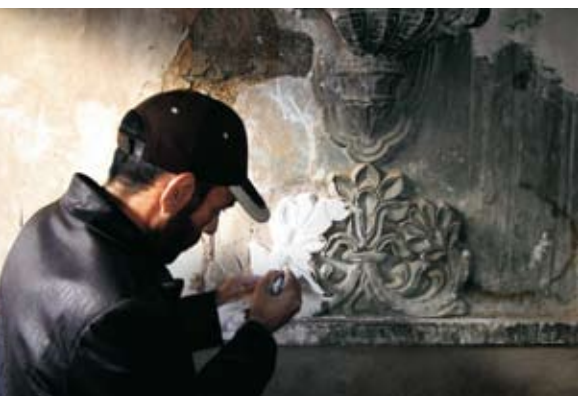
Repair of interior plaster work in the Akhawan house.

In addition to full-scale conservation, small-scale household grants (in the form of materials, labour and on-site advice) have been made available to owners of more than twenty-five traditional homes. The aim is to support owners who had already embarked on repairs, but who might not otherwise be able to undertake these effectively, or afford to complete the works.

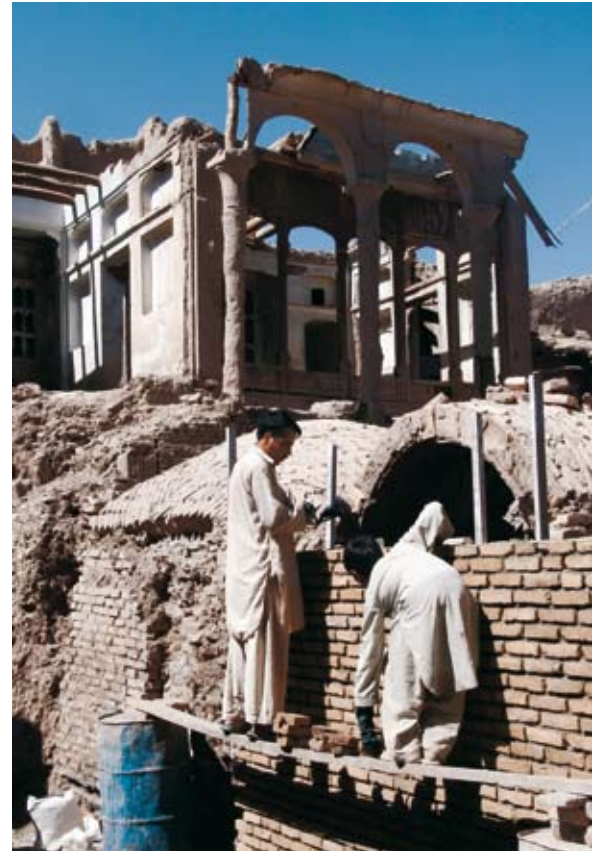
Reconstruction of brick vaults over the hammam wing of the Attarbashi house.

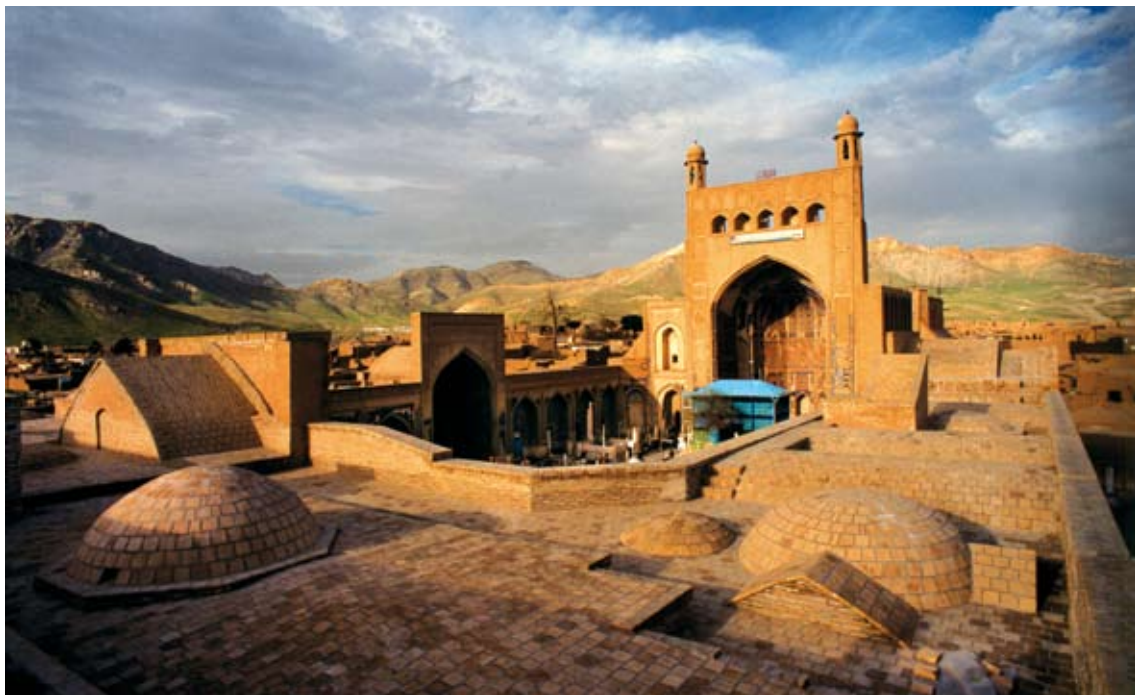
The repaired roofs of the west side of the Abdullah Ansari Shrine Complex.

The initial focus of AKTC interventions was on repairs to the roofs, to prevent further damage to internal plaster and painted decoration. In the case of the Namakdan, structural repairs have had to be made to ensure the stability of the pavilion, which seems to have suffered partial collapse in the past. Reconstruction of the most fragile parts of the structure has enabled the introduction of steel ties in critical parts of the building. The surviving original brick masonry of the central domes has been exposed and restored, as have small sections of glazed tiles on two external elevations. As resources allow, it is envisaged that the garden area around the Namakdan pavilion will be landscaped in a manner befitting a building of this age and importance.
